Manhole Inspection Summary

Manhole # S01YY1018MH

Location Address: **3404 W STRATHMORE AVE**

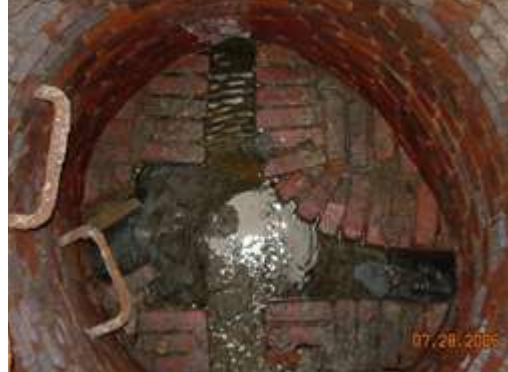
Top View

Adjustment and Corbel infiltration.
Corroded steps. Evidence of surcharge -
Bench debris. Channel debris.

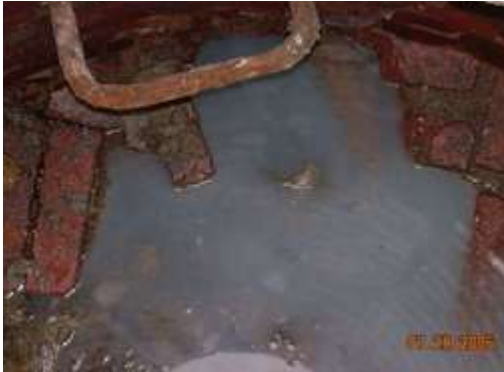
Defect

Corroded steps. Bench deterioration and
loose brick.

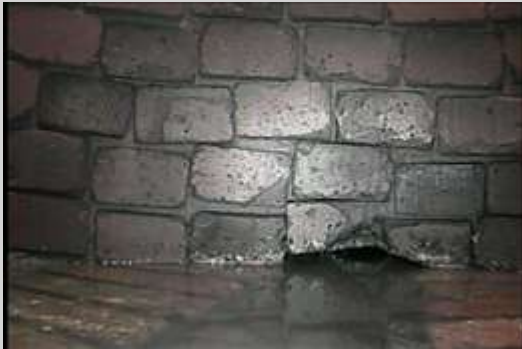
6 in. Circular Gravity Sewer Pipe Out @ 12 O'Clock

Deposits: ☐ None ☐ Mud ☐ Sludge ☒ **Debris** ☐ Grease

Silt Depth: **4** (in.) Deposits Extent: **Medium**

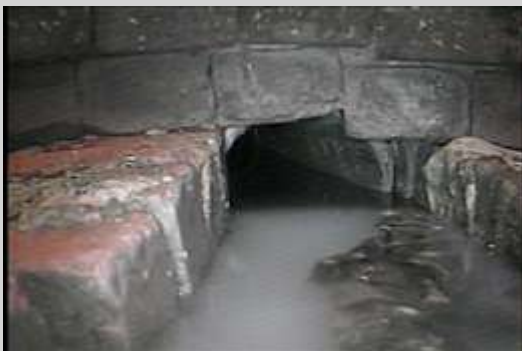
6 in. Circular Gravity Sewer Pipe In @ 3 O'Clock

Deposits: ☐ None ☐ Mud ☐ Sludge ☒ **Debris** ☐ Grease

Silt Depth: **1** (in.) Deposits Extent: **Medium**

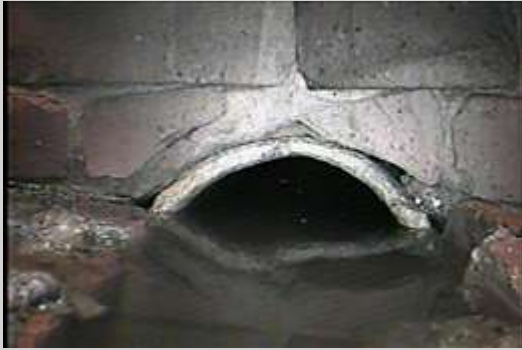
6 in. Circular Gravity Sewer

Deposits: ☐ None ☐ Mud ☐ Sludge ☒ **Debris** ☐ Grease

Silt Depth: **2** (in.) Deposits Extent: **Medium**

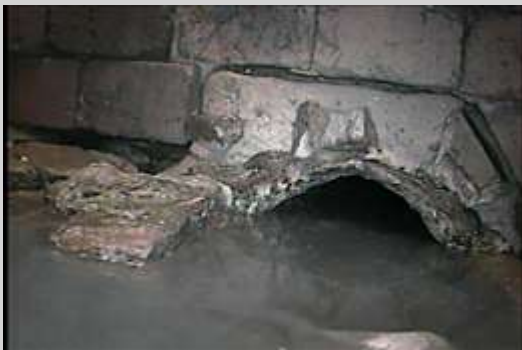
6 in. Circular Gravity Sewer

Bench deterioration.

Deposits: ☐ None ☐ Mud ☐ Sludge ☒ **Debris** ☐ Grease

Silt Depth: **2** (in.) Deposits Extent: **Medium**
